Asbestos Survey Report

Parcel # ADV-62-B-P1
I-49 Lafayette Connector
410 Mudd Avenue
Lafayette, Louisiana

October 3, 2019
LA DOTD Project No. H.003453
Terracon Project No. EH197174

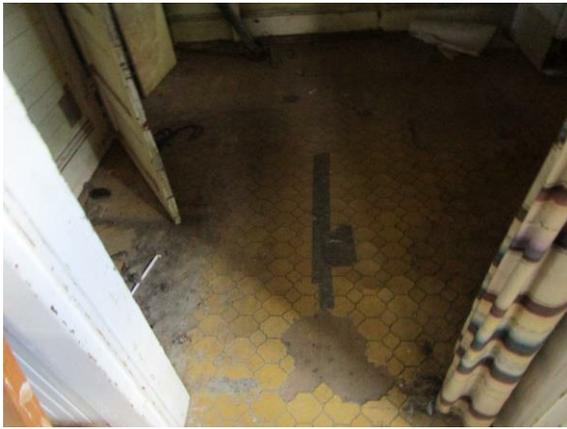
Photograph No. 1

- Fiber backing associated with the tan vinyl sheet flooring located in the kitchen, dining area and living room;
- 12x12 Beige floor tile with black mastic over wood flooring in dining area (under tan vinyl sheet flooring)

View of the Tan linoleum with associated fiber backing (HA-01)

Terracon recommends that the identified ACM be removed and disposed of by a Louisiana-licensed asbestos abatement contractor prior to any renovation activity that will disturb the asbestos-containing materials identified.

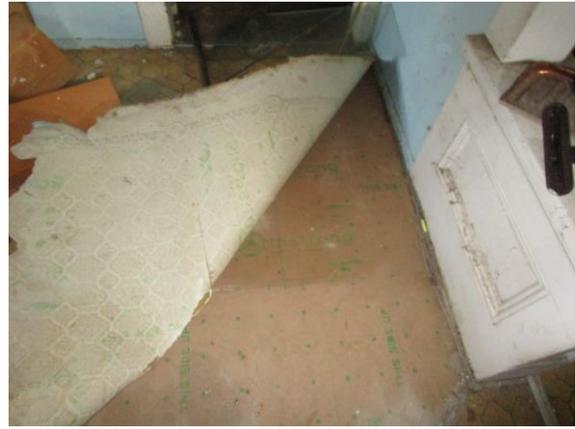
Photograph No. 2

View of associated fiber backing of the tan linoleum (HA-01)

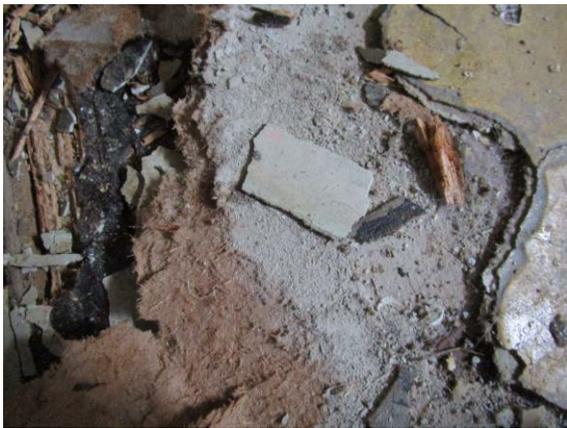
Photograph No. 3

View of the floor tile with black mastic (HA-02).

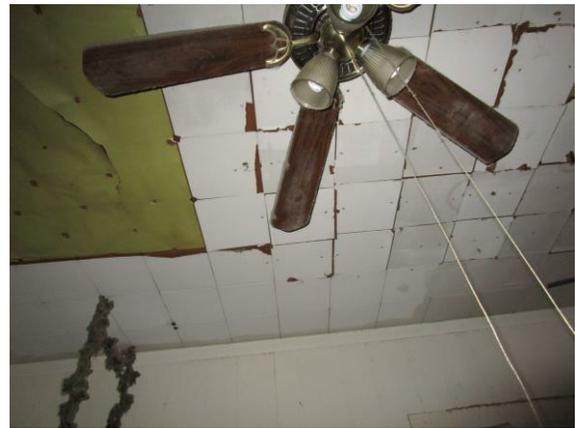
Photograph No. 4

View of the 12x12 white interlocking ceiling tile (HA-03)

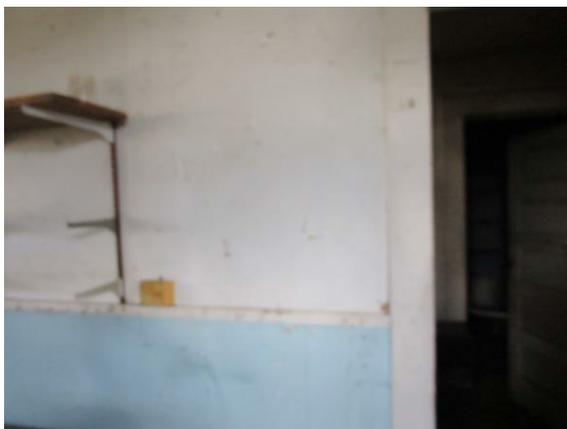
Photograph No. 5

- Wallboard with Joint Compound located in the dining area, living room, and hallway

Although these materials are not considered asbestos-containing, the OSHA asbestos standard for construction (29 CFR 1926.1101) regulates workplace exposure to asbestos regardless of concentration. The OSHA standard requires that employee exposure to airborne asbestos fibers be maintained below 0.1 asbestos fibers per cubic centimeter of air (0.1 f/cc). The disturbance of this material has the potential to result in the release of airborne asbestos fibers

View of White Wallboard with Joint Compound (HA-04).

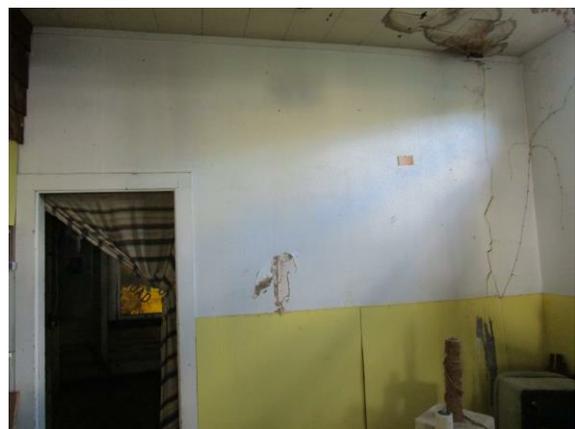
Photograph No. 6

- White rough wall texture on the south wall of the dining area;

According to LDEQ and EPA NESHAP regulations, friable ACM is considered RACM and is required to be abated prior to demolition.

View of the rough wall texture (HA-05)

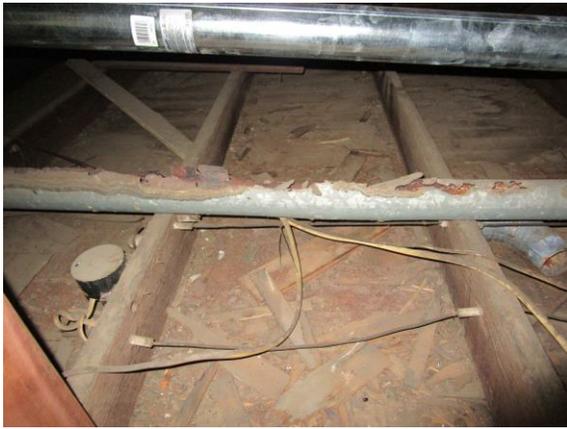
Photograph No. 7
View of the TSI straight pipe insulation (HA-06)

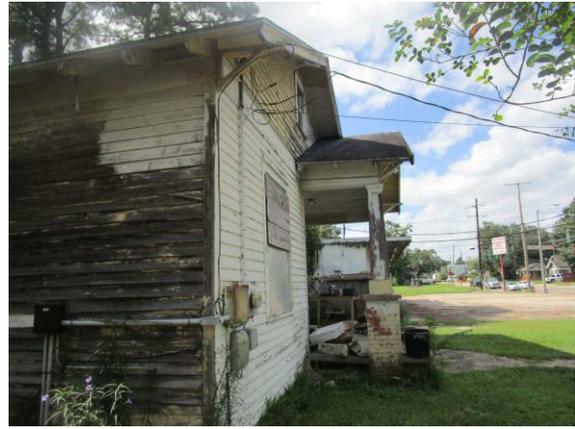
Photograph No. 8
View of the shingled roof HA-07
